## Post Installation Report

Shapwick Parish Council

Shapwick Play Park

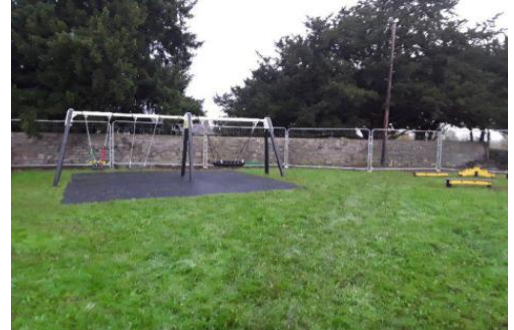
**Item:** Site General  
**Manufacturer:** Owner/Operator  
**Surface Type:** N/A  
**Item Quantity:** 1  
**Equipment Compliance:** N/A  
**Surface Area Compliance:** N/A

It is recommended that signage, with information including the site address, contact information for maintenance issues and emergency contact details are provided for the facility - Provide in accordance with the recommendations

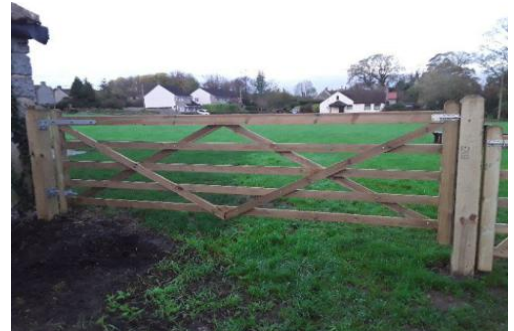
**Item:** Gate - Maintenance  
**Manufacturer:** Not Identified  
**Surface Type:** Grass  
**Item Quantity:** 2  
**Equipment Compliance:** N/A  
**Surface Area Compliance:** N/A

There is no padlock on the maintenance gate - Provide a padlock to secure the gate

There are openings that are less than 12mm that could trap or crush fingers - Provide a 12mm gap throughout full range of motion at both sides of gate

There are projecting bolt thread(s) present - Remove excess thread length and deburr or provide cap

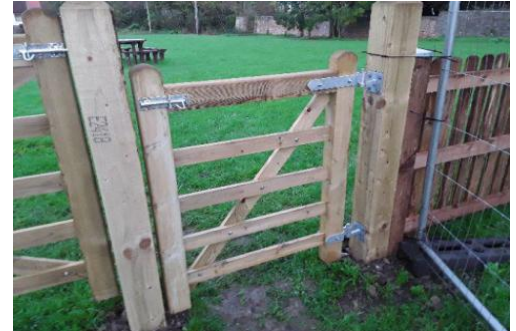
**Item:** Gate  
**Manufacturer:** Not Identified  
**Surface Type:** Grass  
**Item Quantity:** 1  
**Equipment Compliance:** N/A  
**Surface Area Compliance:** N/A

There are projecting bolt thread(s) present - Remove excess thread length and deburr or provide cap

There is no securing split pin on the hinge - Refer to the contractor

There are openings that are less than 12mm that could trap or crush fingers - Provide a 12mm gap throughout full range of motion at both sides of gate

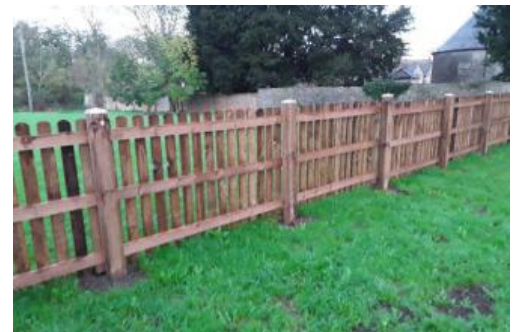
**Item:** Fencing - Timber  
**Manufacturer:** Not Identified  
**Surface Type:** Grass  
**Item Quantity:** 1  
**Equipment Compliance:** N/A  
**Surface Area Compliance:** N/A

This item is satisfactory - no work required -

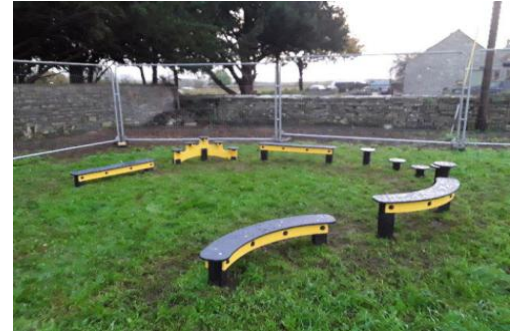
**Item:** Activity Trail  
**Manufacturer:** Not Identified  
**Surface Type:** Grass  
**Item Quantity:** 1  
**Equipment Compliance:** Yes  
**Surface Area Compliance:** Yes

There is no identification label affixed to the equipment - Provide an identification label

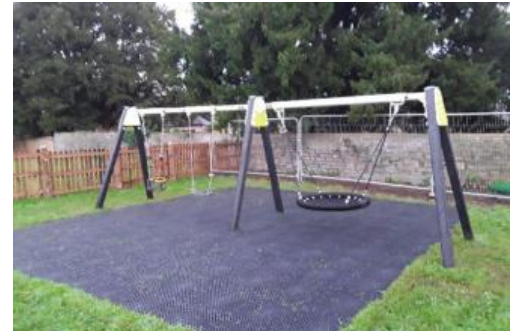
**Item:** 2 Bay Swing  
**Manufacturer:** Boer  
**Surface Type:** Grass Matrix Tiles  
**Item Quantity:** 1  
**Equipment Compliance:** Yes  
**Surface Area Compliance:** Yes

This item is satisfactory - no work required -

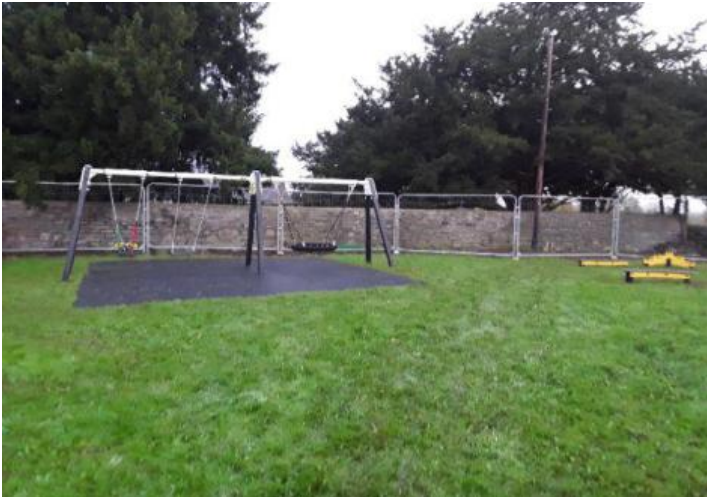
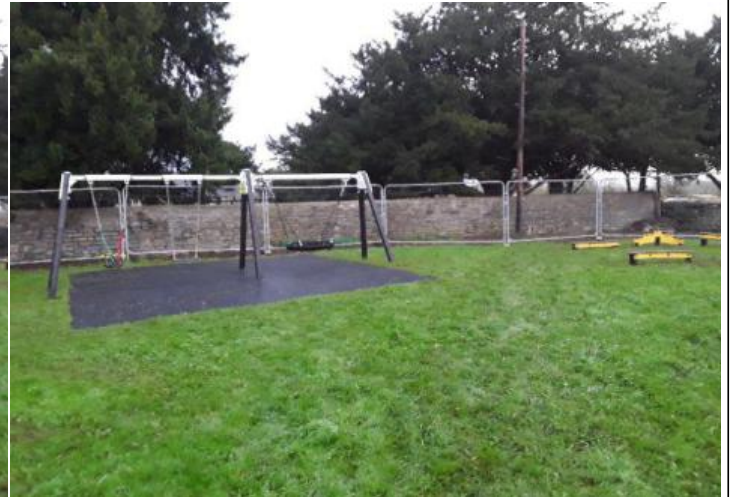
**Item:** Ancillary Items - Site General  
**Manufacturer:** Owner/Operator

**Finding:** It is recommended that signage, with information including the site address, contact information for maintenance issues and emergency contact details are provided for the facility

**Action:** Provide in accordance with the recommendations

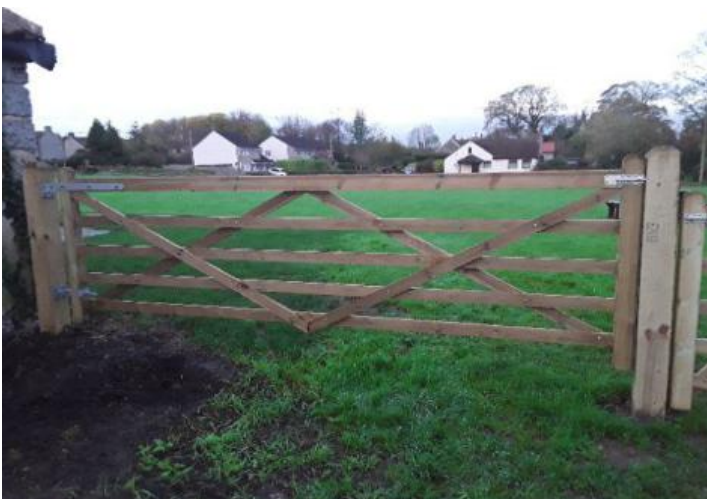
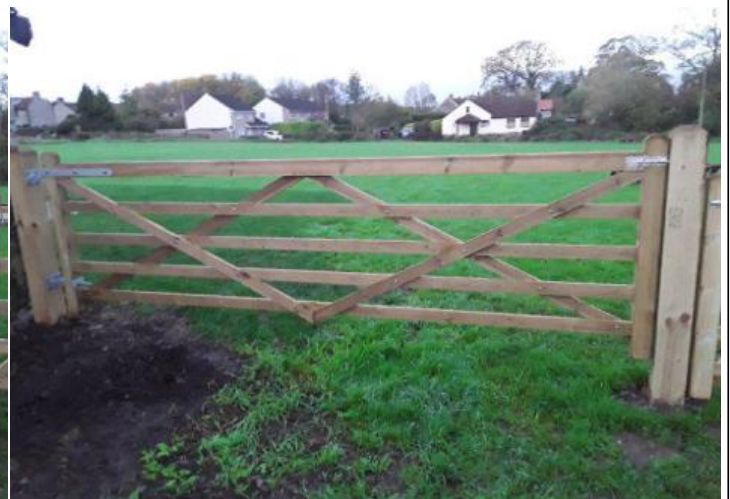
**Item:** Gates - Gate - Maintenance  
**Manufacturer:** Not Identified

**Finding:** There is no padlock on the maintenance gate

**Action:** Provide a padlock to secure the gate

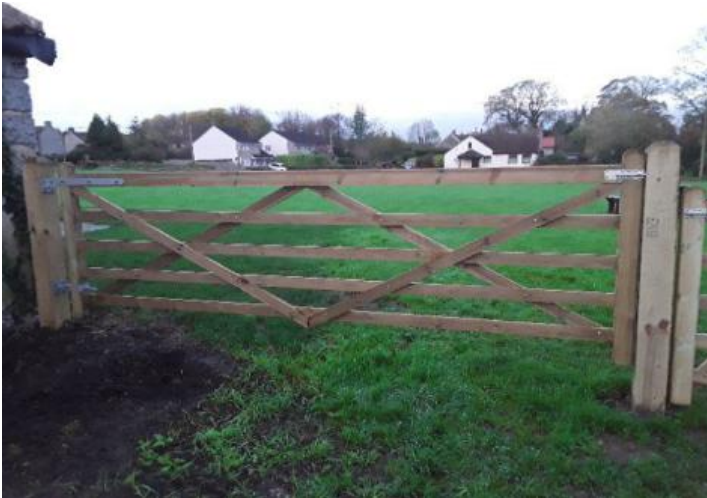
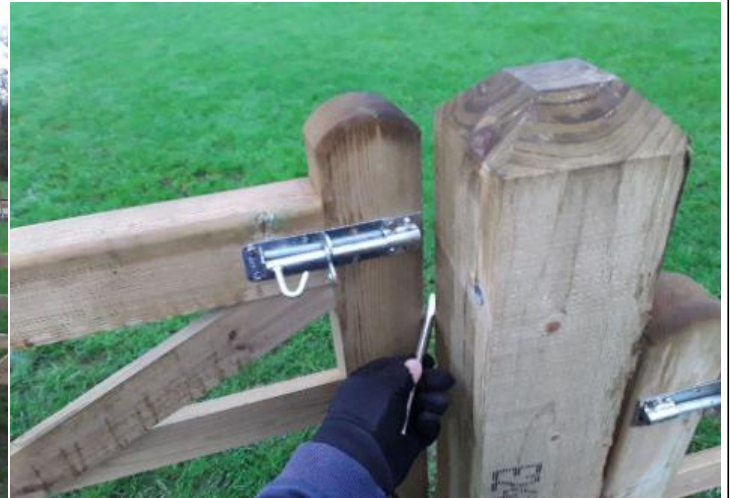
**Item:** Gates - Gate - Maintenance  
**Manufacturer:** Not Identified

**Finding:** There are openings that are less than 12mm that could trap or crush fingers

**Action:** Provide a 12mm gap throughout full range of motion at both sides of gate

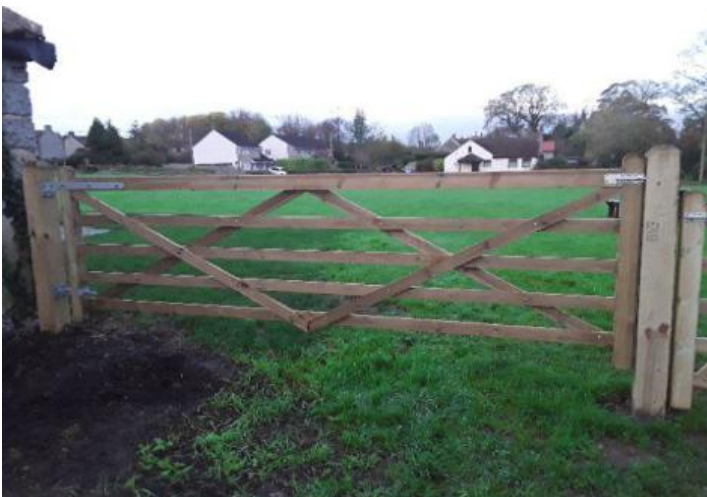
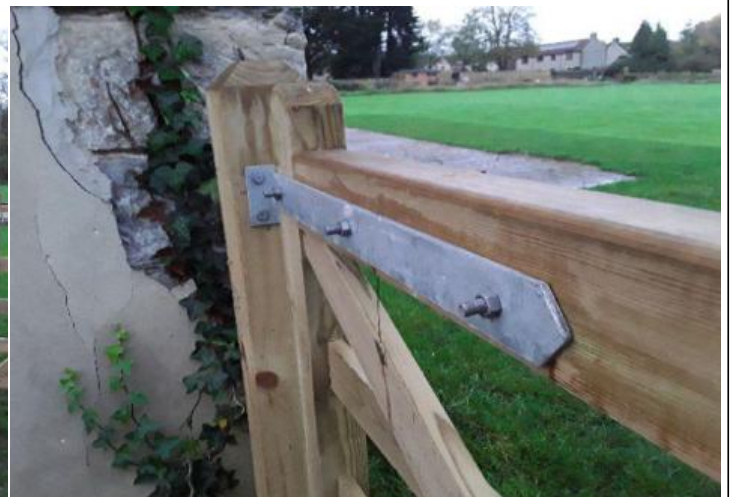
**Item:** Gates - Gate - Maintenance  
**Manufacturer:** Not Identified

**Finding:** There are projecting bolt thread(s) present

**Action:** Remove excess thread length and deburr or provide cap

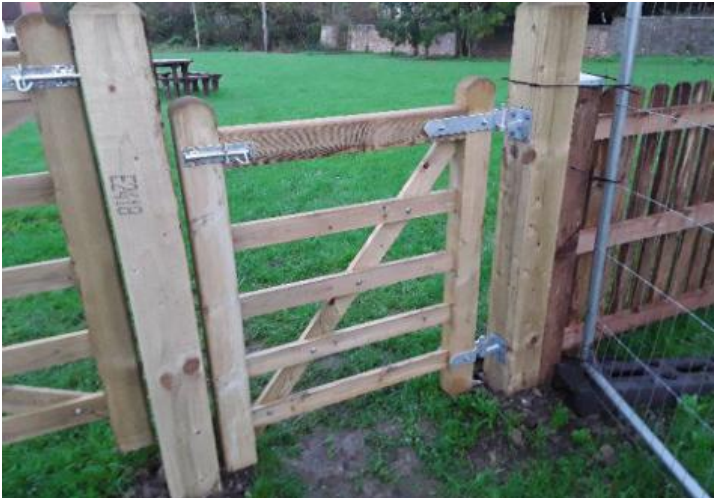
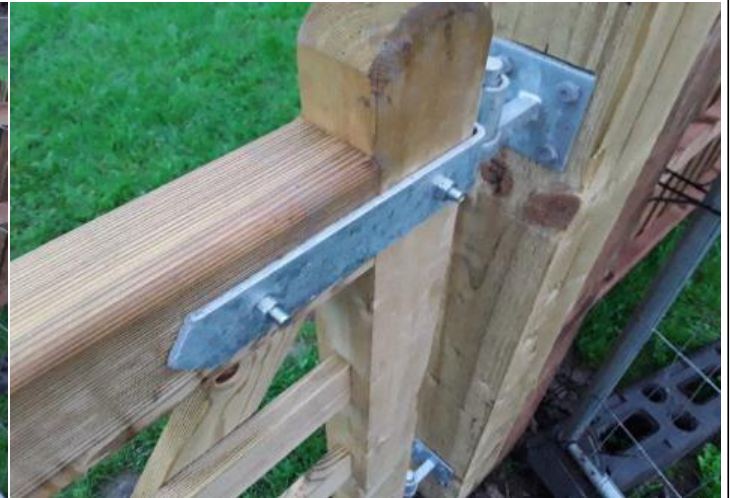
**Item:** Gates - Gate  
**Manufacturer:** Not Identified

**Finding:** There are projecting bolt thread(s) present

**Action:** Remove excess thread length and deburr or provide cap

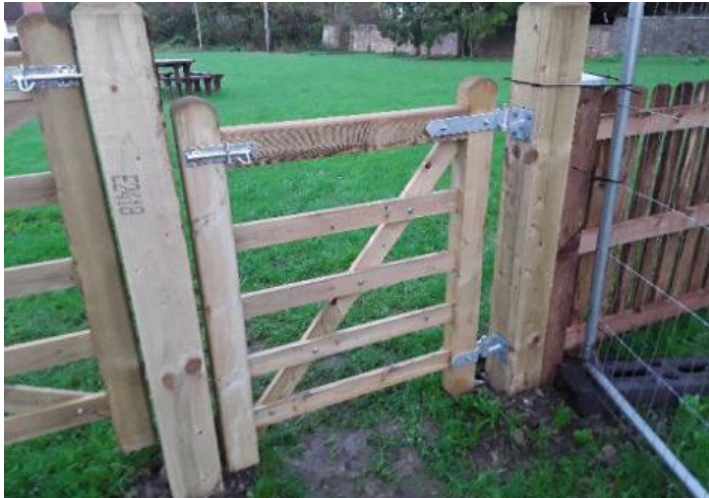
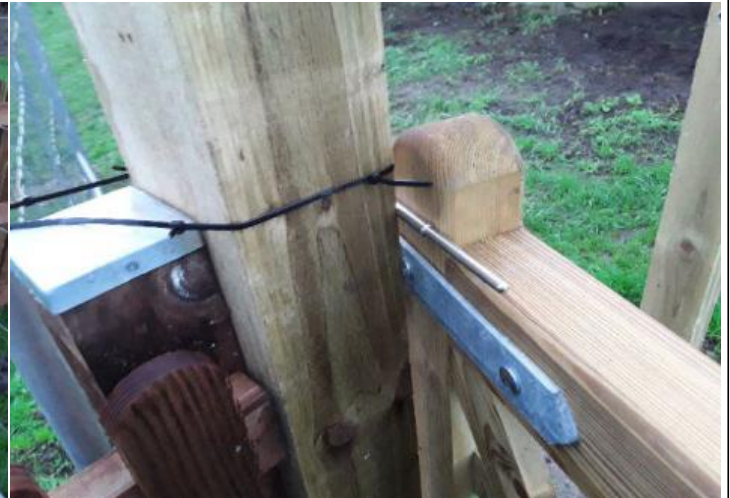
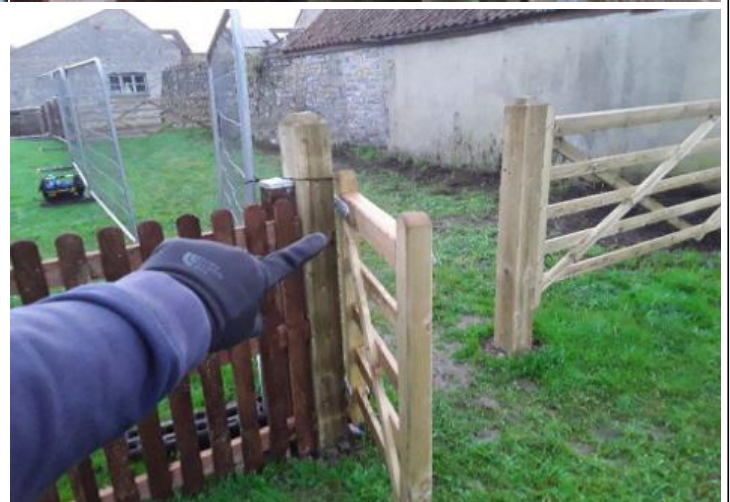
**Item:** Gates - Gate  
**Manufacturer:** Not Identified

**Finding:** There are openings that are less than 12mm that could trap or crush fingers

**Action:** Provide a 12mm gap throughout full range of motion at both sides of gate

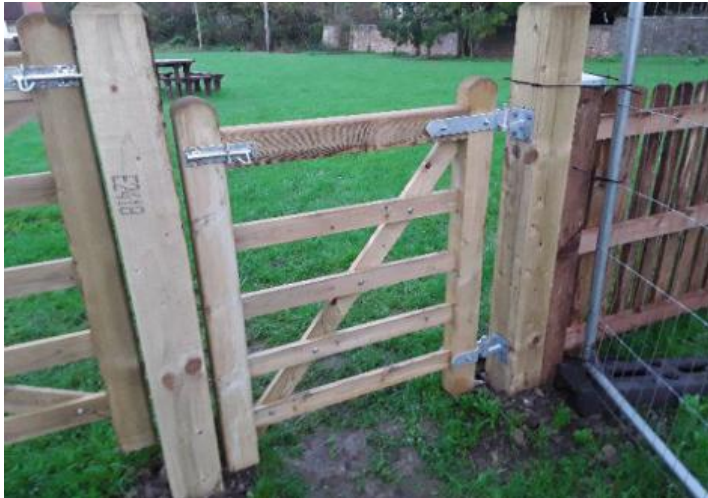
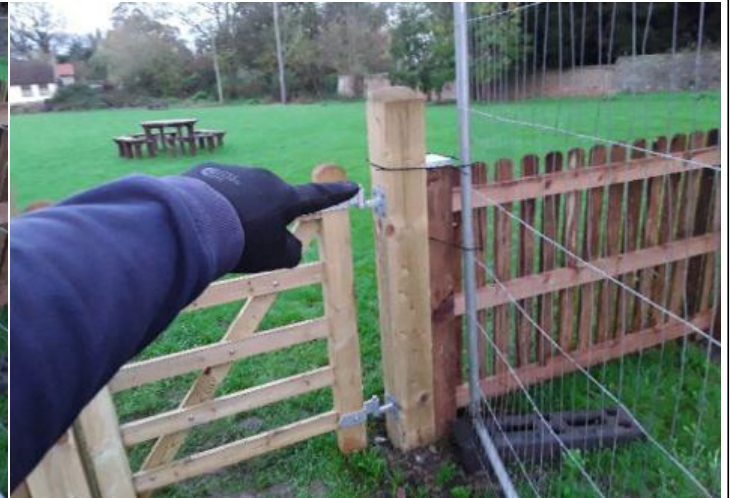
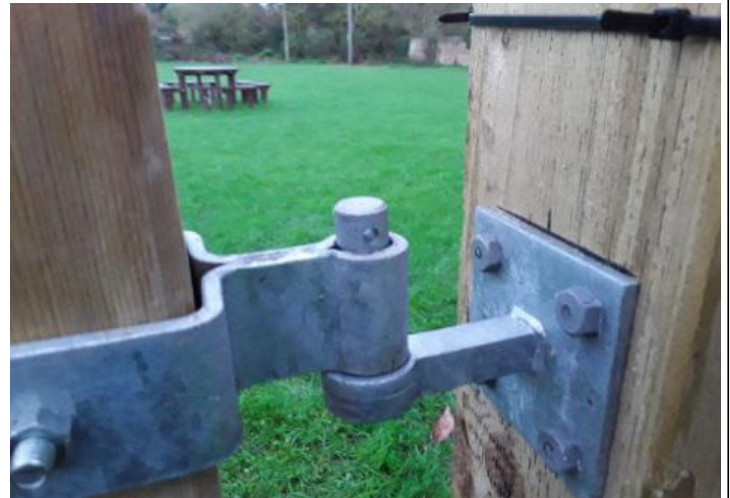
**Item:** Gates - Gate  
**Manufacturer:** Not Identified

**Finding:** There is no securing split pin on the hinge

**Action:** Refer to the contractor

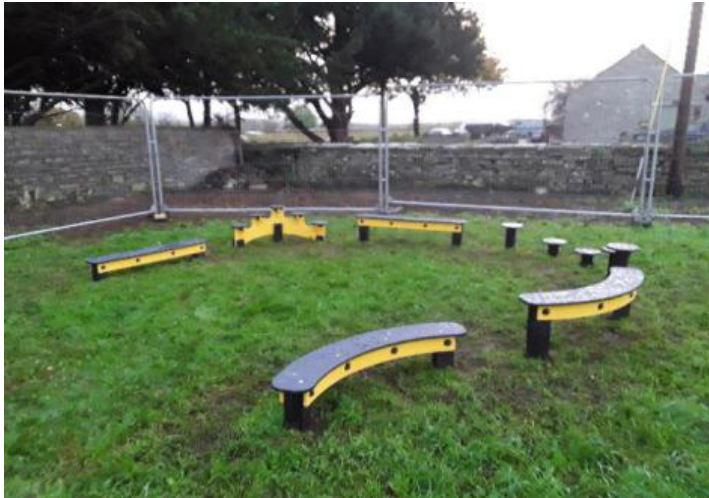
**Item:** Activity Equipment - Activity Trail  
**Manufacturer:** Not Identified

**Finding:** There is no identification label affixed to the equipment

**Action:** Provide an identification label
